KEMAH LAKE DAM

NJ 00268

PHASE 1 INSPECTION REPORT
NATIONAL DAM SAFETY PROGRAM
DACW 61-79-C-0011

JUNE 1981

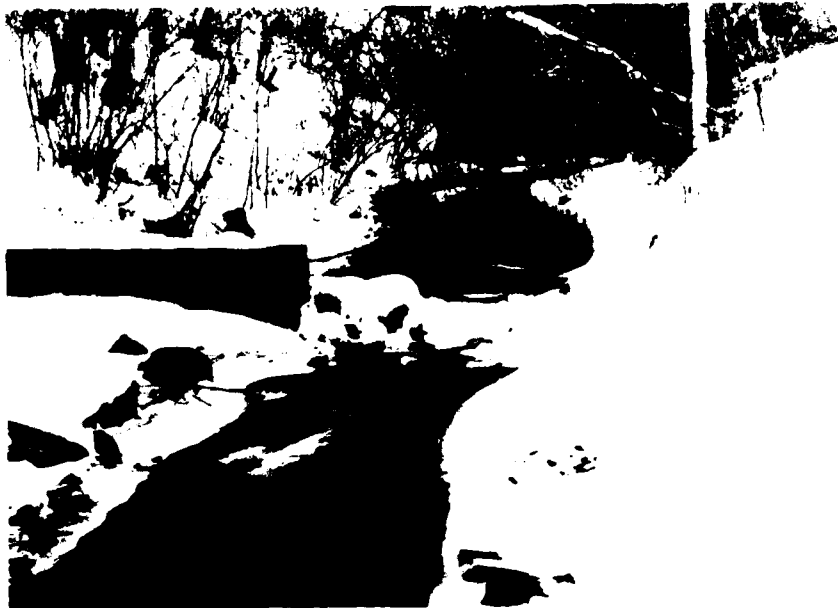
The concrete notched weir was in satisfactory condition and the stoplog was not in place. The approach and discharge channels were in generally satisfactory condition. The spillway discharge culvert appeared to be in satisfactory condition. The stone rubble headwalls at each end of the culvert appeared to be in satisfactory condition. The entrance to the culvert was significantly overgrown by bushes. The low level outlet pipe could not be observed at the toe of the roadway berm. However, a stream of water containing orange colored deposits, flowing with a trickle, was observed at the approximate location of the outlet pipe. No operating mechanism was observed.

PHOTO 1
CONCRETE NOTCHED WEIR COMPRISING SPILLWAY

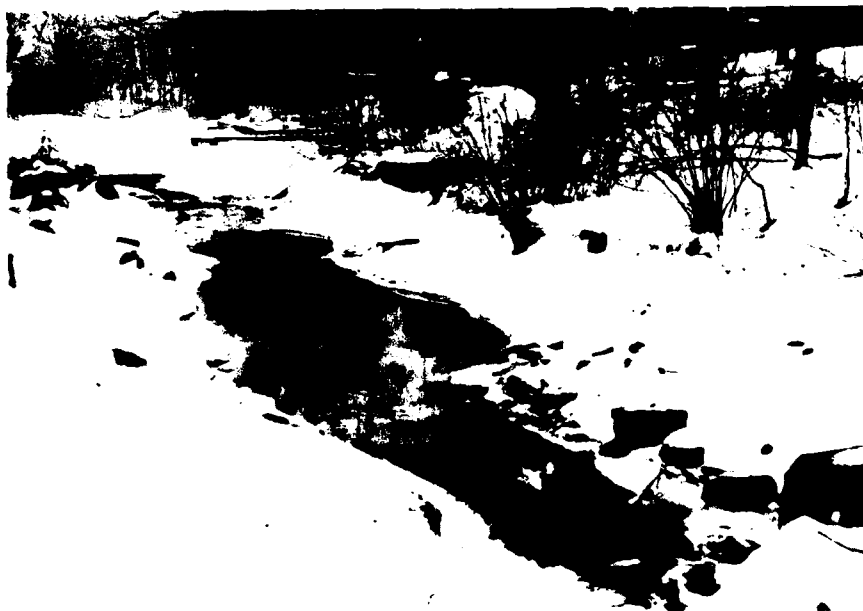
PHOTO 2
SPILLWAY APPROACH CHANNEL
